UNITED STATES DEPARTMENT OF THE INTERIOR
NATIONAL PARK SERVICE
NATIONAL REGISTER OF HISTORIC PLACES
REGISTRATION FORM

historic name Valentown Hall

Valentown Hall
Victor, Ontario County, New York

Section 7, Description, page 1

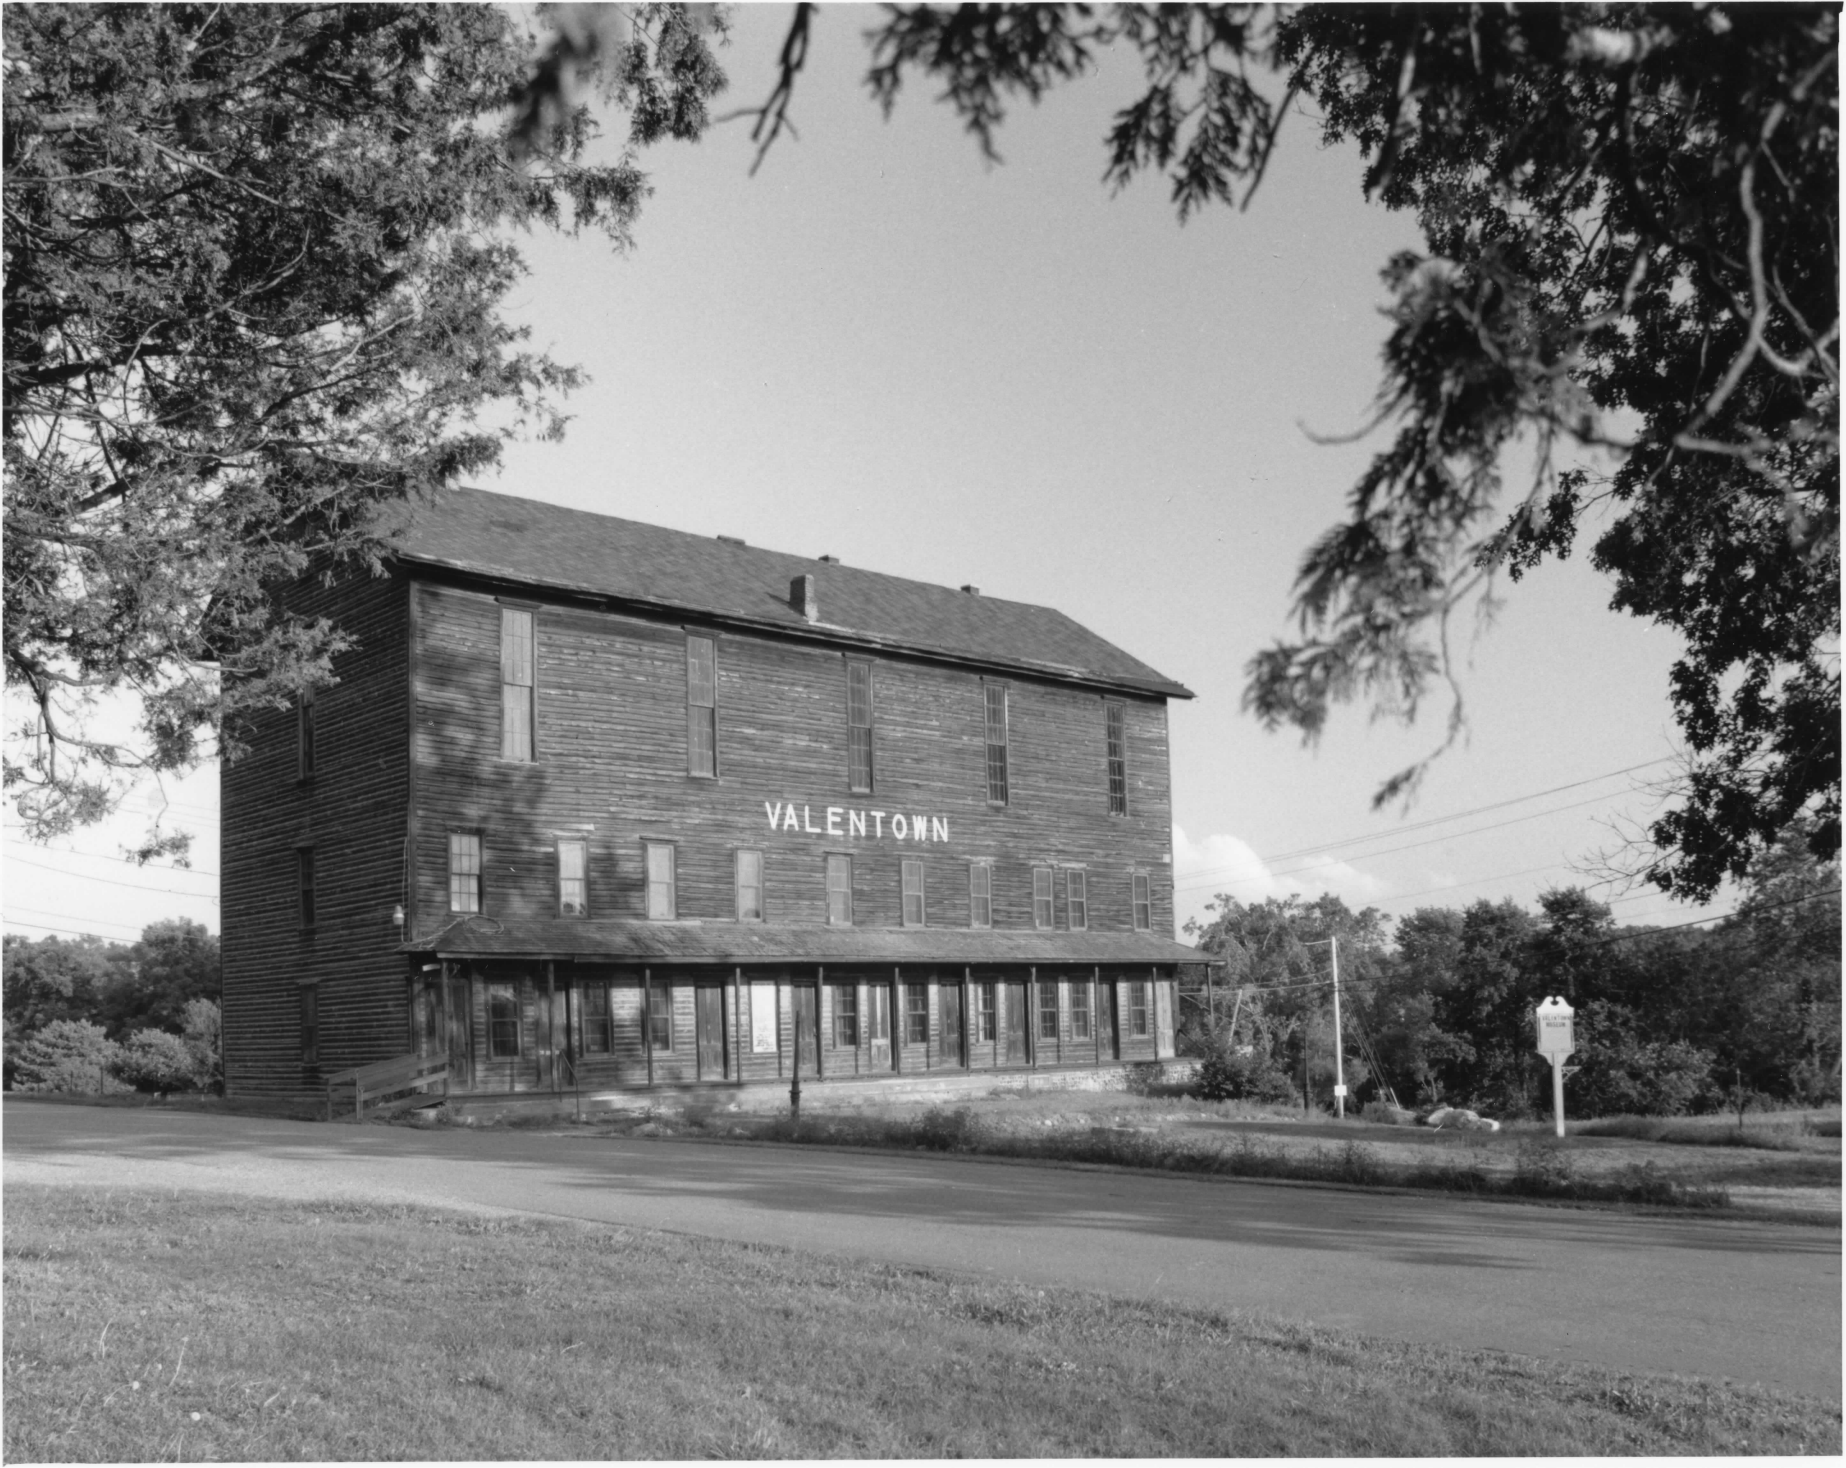
Valentown Hall, ~~Victor~~, Ontario Co
Valentown Square - Box 456
Fishers, New York 14453
(716) 924-1810

Photo: S. King, Rochester, 1996
Neg: OPRHP, Albany

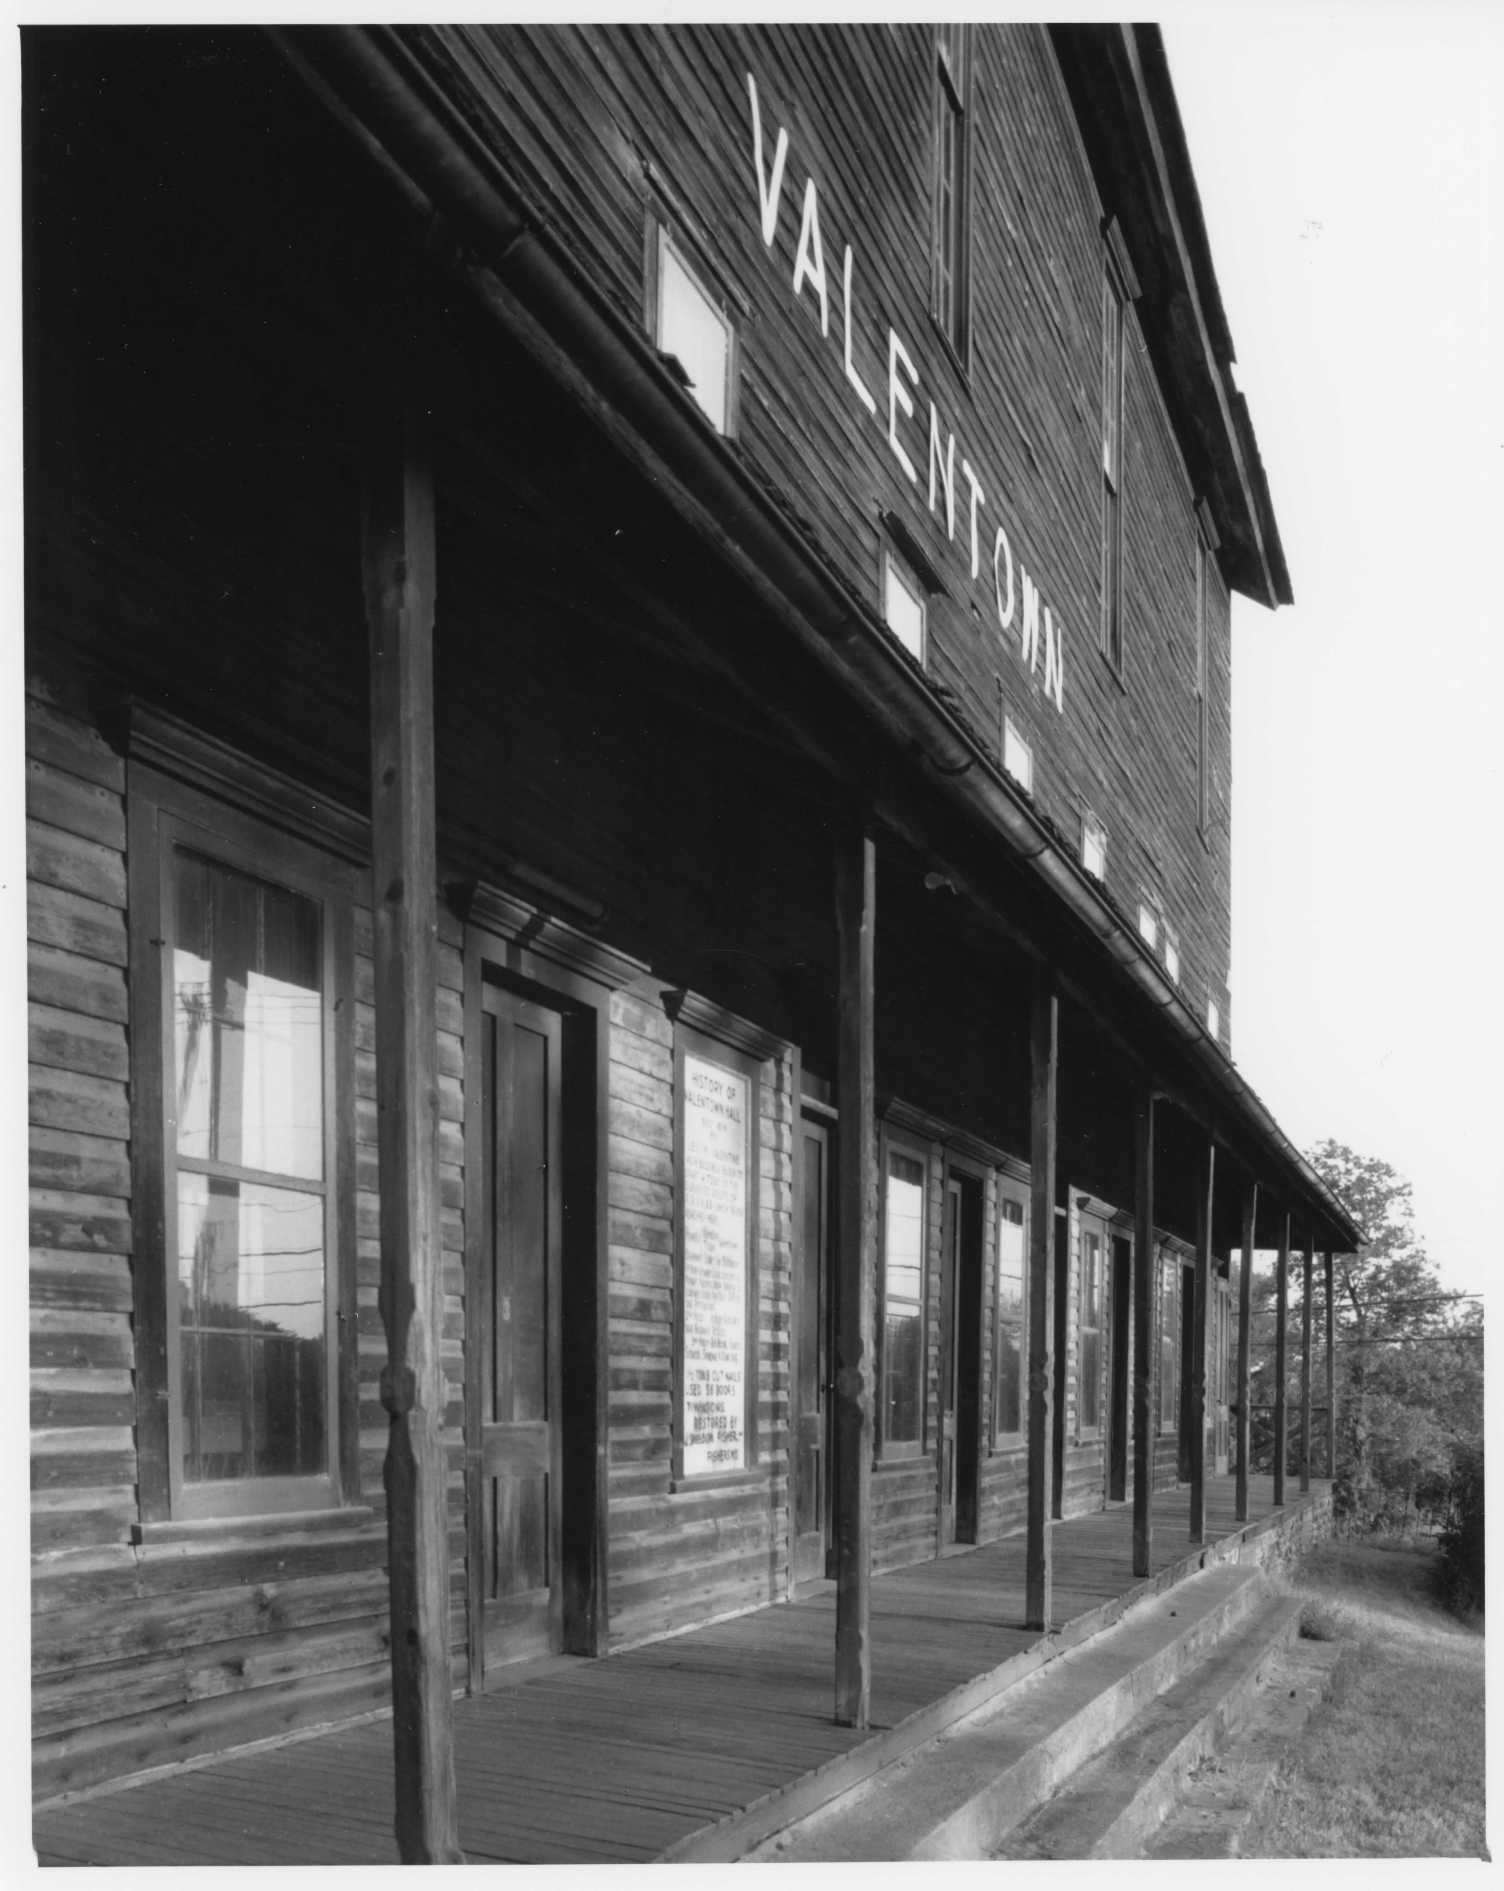
Valentown Hall, Victor, Ontario Co.
Valentown Square - Box 456
Fishers, New York 14453

Photo: S. King, Rochester, 1996
Neg: OPRHP, Albany

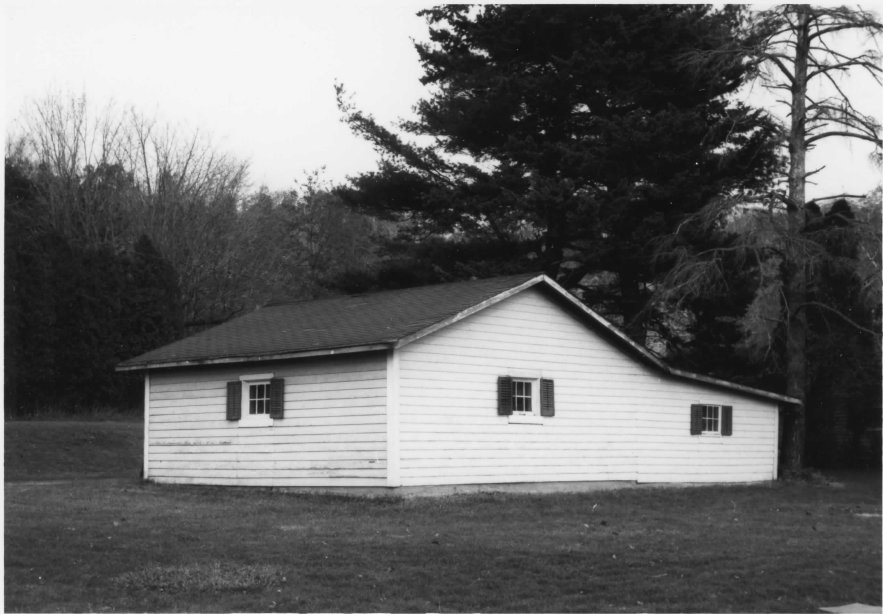
View: contributing garage
behind 1830s farmhouse

There are four contributing support buildings associated with Valentown Hall, including an early nineteenth century farmhouse and its three dependencies: an outhouse, a shed and a garage. The farmhouse, believed to date from the 1830s/40s, is a modest, Greek Revival style building with a rectangular, gable-roofed form. It is distinguished by finely crafted, vernacular period detailing (including a slightly recessed, trabeated, off-center doorway and cast-iron grilles in several of the attic windows) and a cobblestone foundation. The outhouse is a small, rectangular, gable-roofed building with vertical board siding; the shed is a rectangular, shed-roofed building with weathered vertical siding, and the garage, believed to date from the early twentieth century, is a rectangular, salt-box-like building with horizontal board siding.

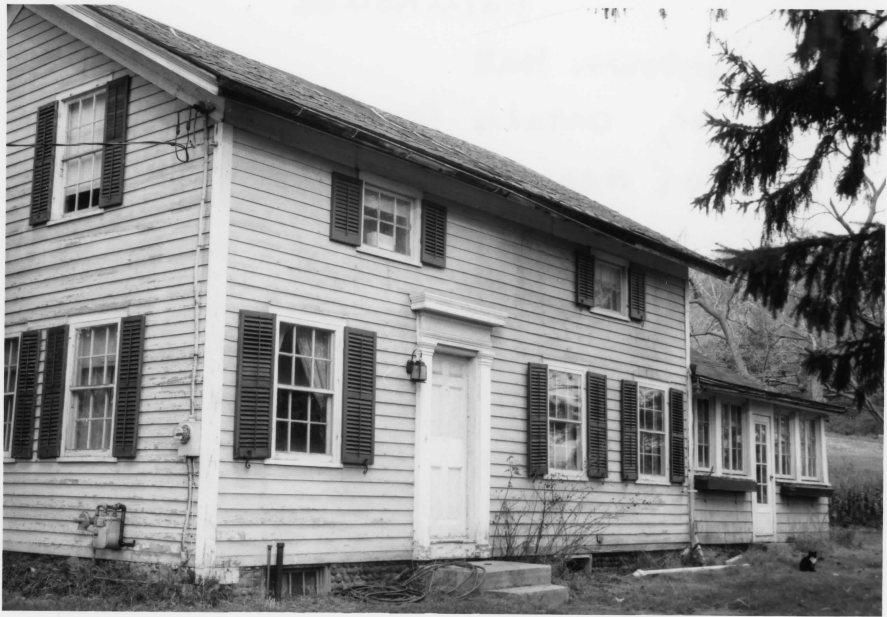
Farmhouse

View: Front facade of
contributing farmhouse

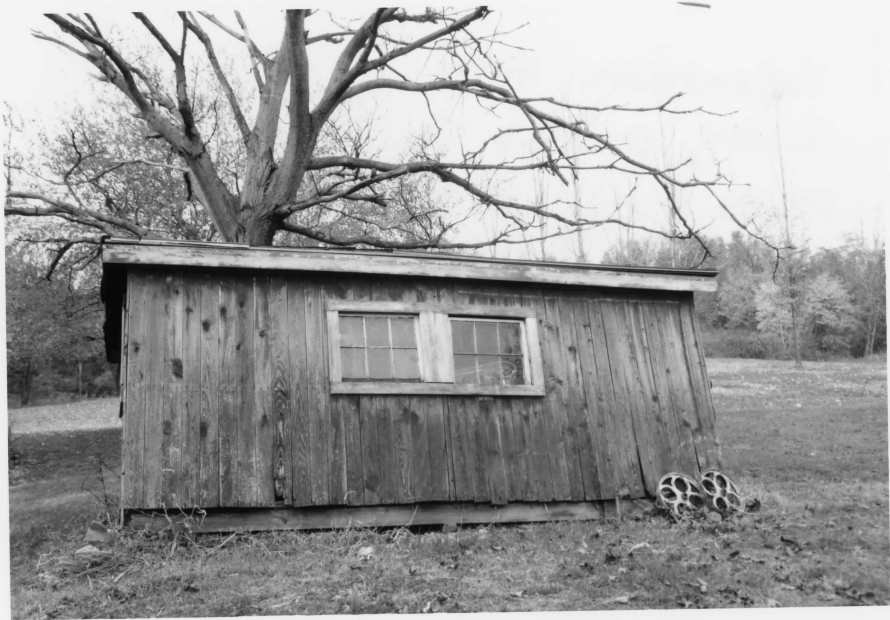
View: contributing shed behind
ca 1830s farmhouse

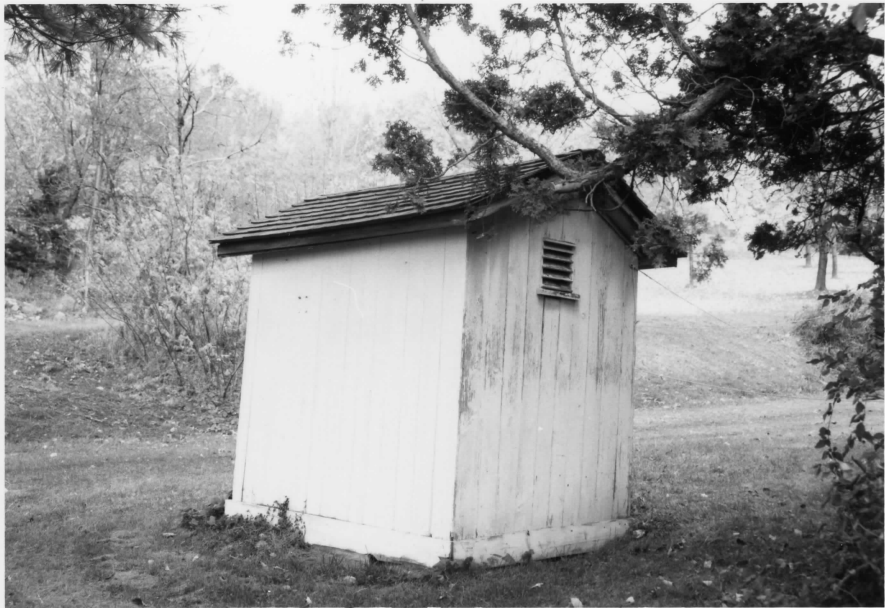
View: contributing outhouse
behind ca 1830s farmhouse
